Casino Collapse

OSHA Steel Erection Standard

Draft 7 15 2019

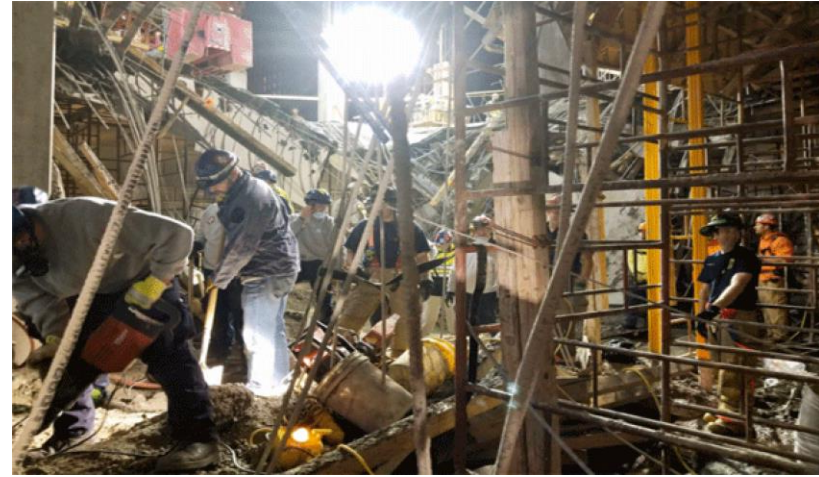
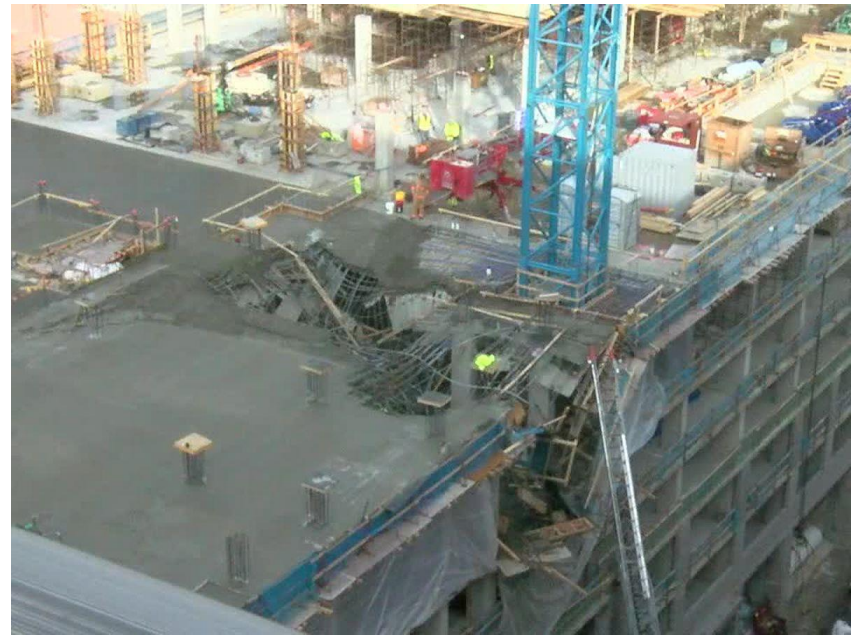
Nov 2019

- Cincinnati
- Too few bolts connecting horizontal steel support beams with vertical steel columns was the cause of January's construction accident at Horseshoe Casino Cincinnati, according to the report of the Occupational Safety and Health Administration.
- Preston Delph, 58, was on the sixth floor

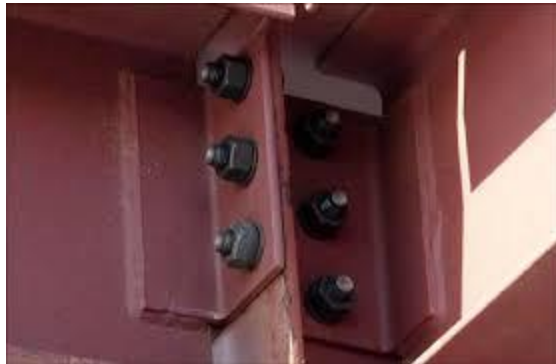
**Table 7-1
Available Shear
Strength of Bolts, kips**

Follow AISC Steel Construction Manual, 13th Edition, Table 7-1, Available Shear Strength of Bolts.

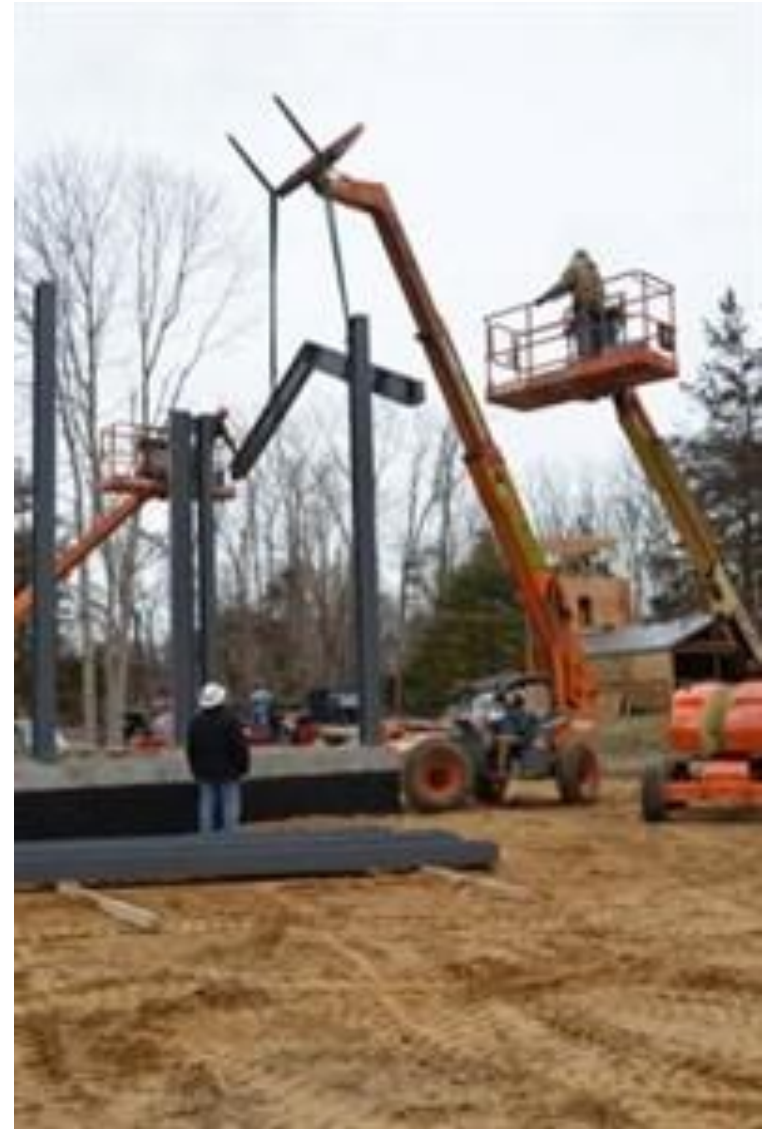
- South Chicago Heights
- Employee 1 was operating a Powered Industrial Vehicle (forklift) while lifting a steel column using a nylon strap.
- As employee 1 was lifting the column, the strap broke causing the column to strike employee 2.
- Employee 2 was fatally injured as a result of the incident.

Lifting with a forklift and fiber slings is dangerous.

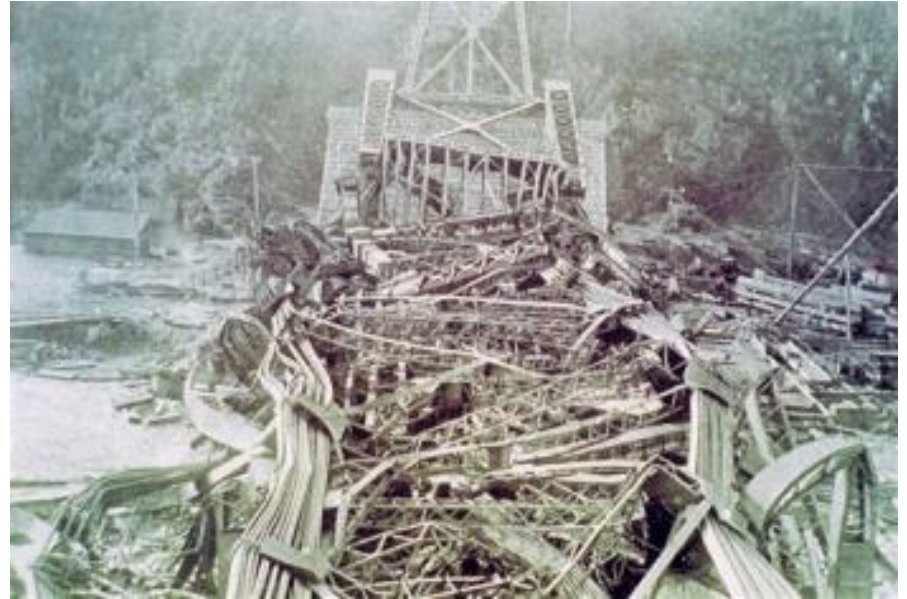
Quebec Bridge Disaster

- August 9, 1907
- 50 ironworkers and 36 other workers were killed.
- 20,000 ton sector fell.
- Cantilever beams buckled.
- Ironworkers expected to only work 10 years before death or serious injury.

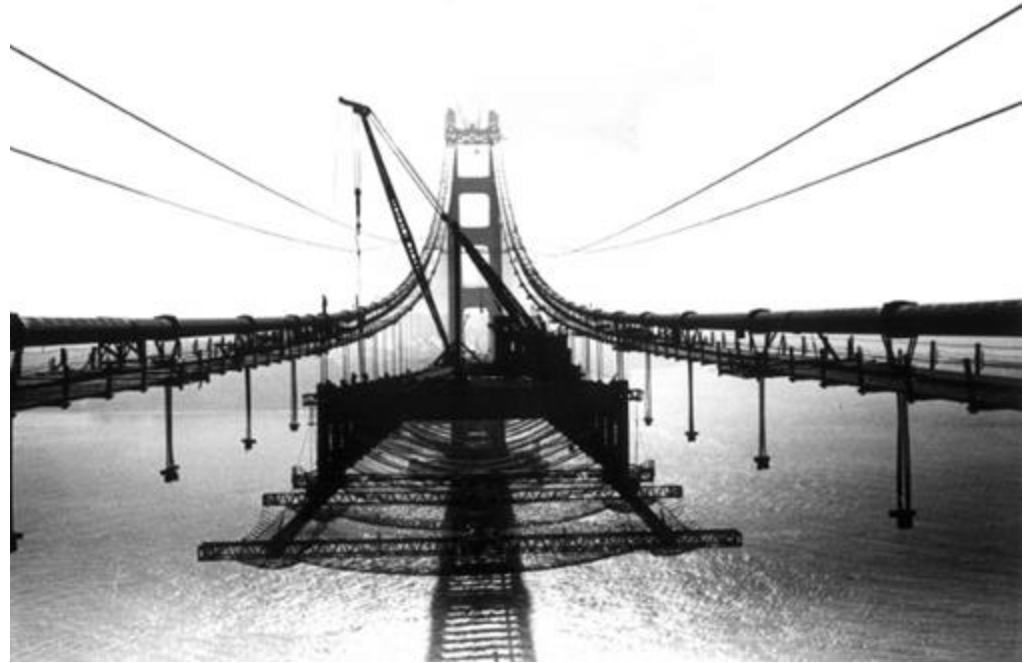
Golden Gate Bridge

- 11 workers died.
- Installed first safety net on a bridge.
- 19 workers saved.

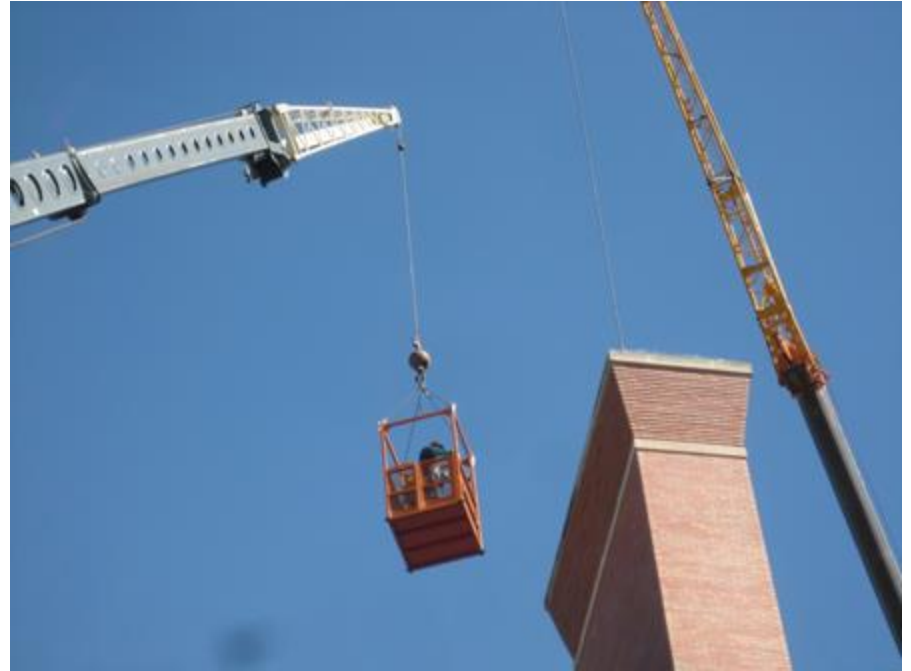
State of Illinois Building

- December 11, 1981
- 3 Ironworkers and 2 others died in 100 foot fall.
- $\frac{3}{4}$ lifting bar failed.
- “Heard a pop.”
- \$8500 penalty by OSHA.

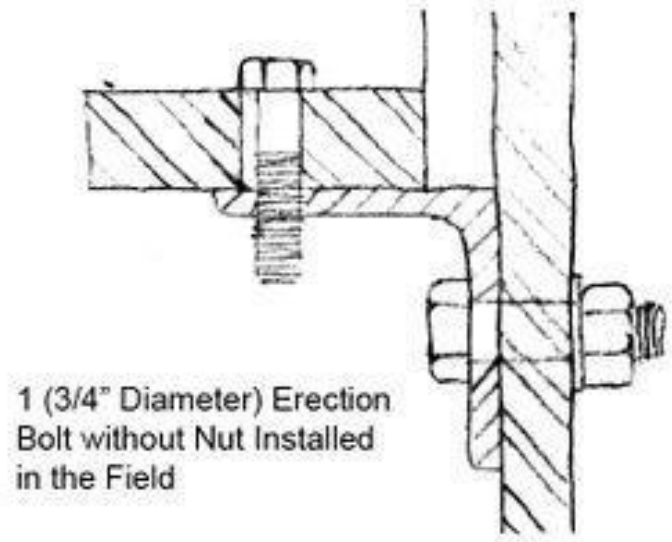
Changes in fabrication made the use of the one-inch diameter bolts impossible. Had to switch to $\frac{3}{4}$ -inch diameter bolts.

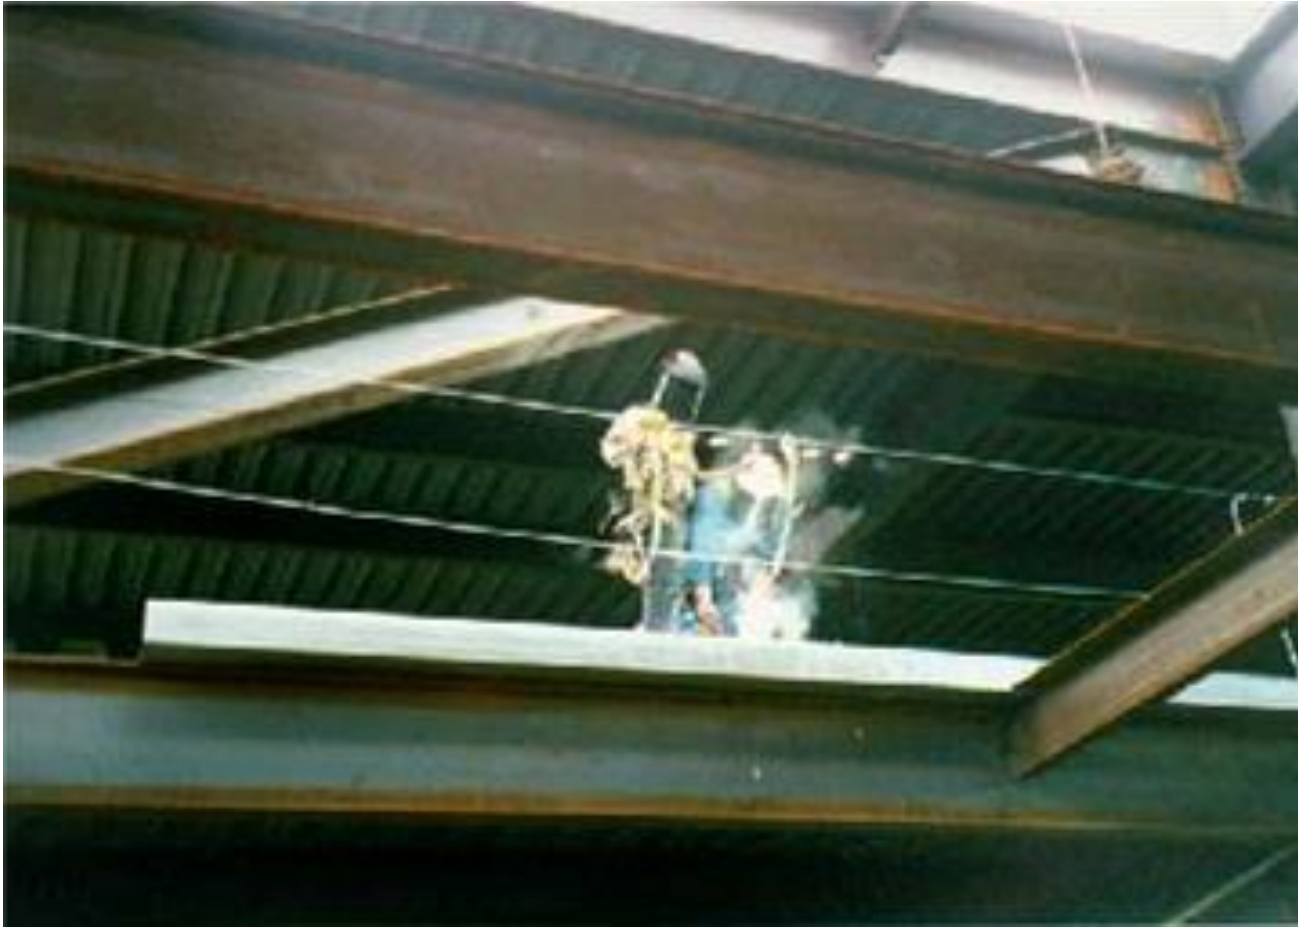
Ironworkers welding at the edge of the deck opening, using the cables as a fall arrest system.

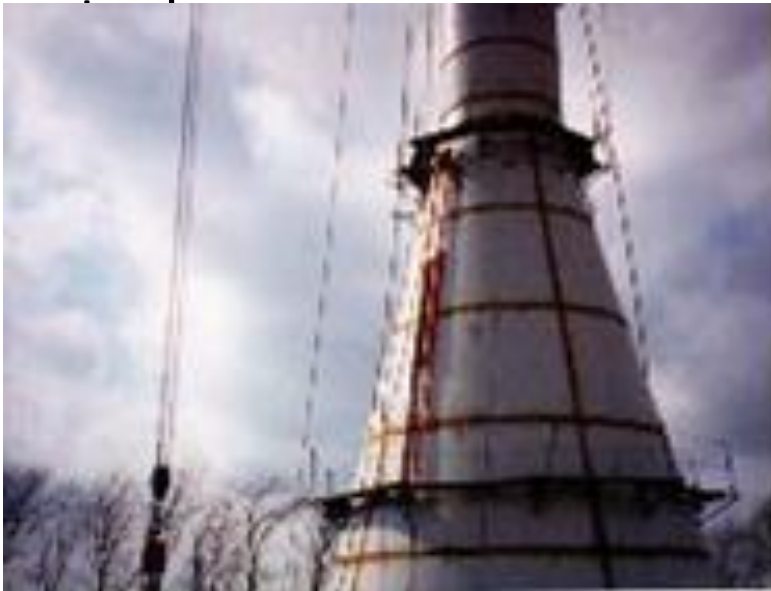
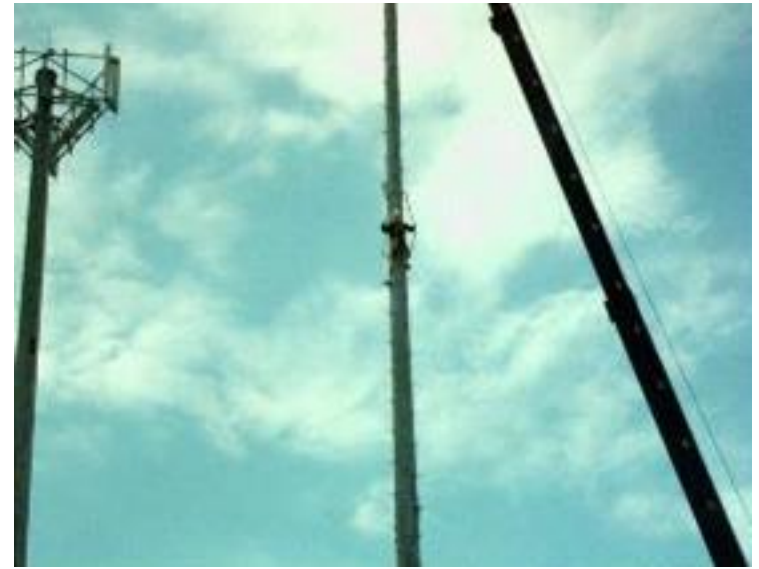
Ironworker using rope grabs to make tower connection.

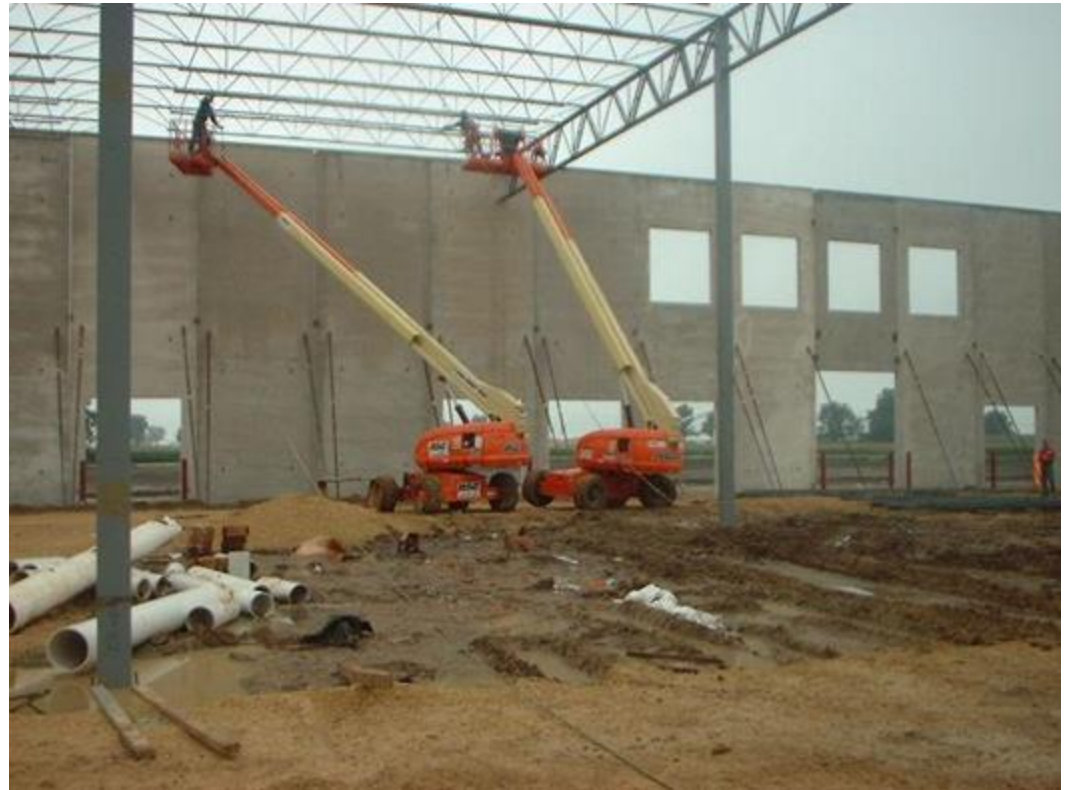
Only parts of the job were graded.

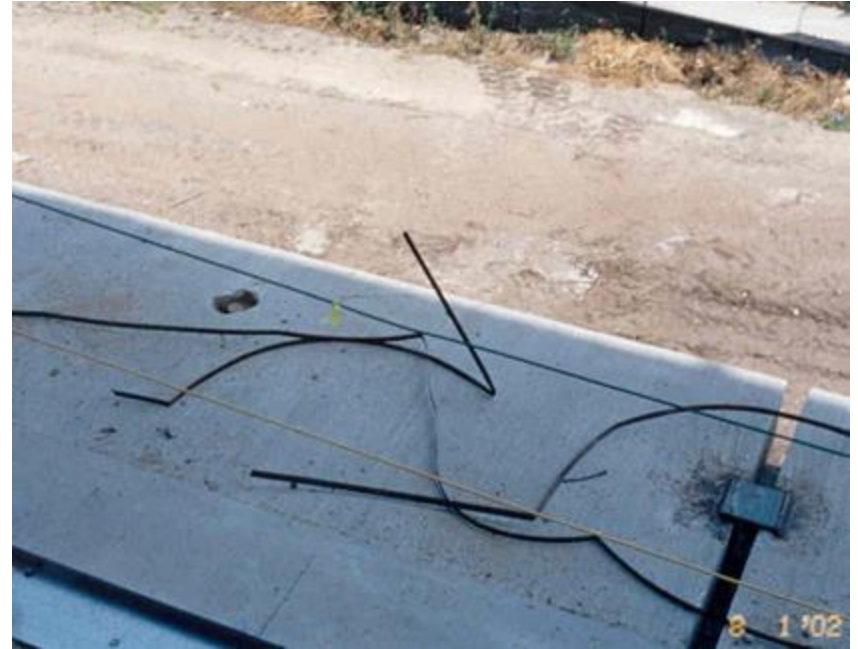
Electric wire is not acceptable as a guardrail - Batavia, IL.

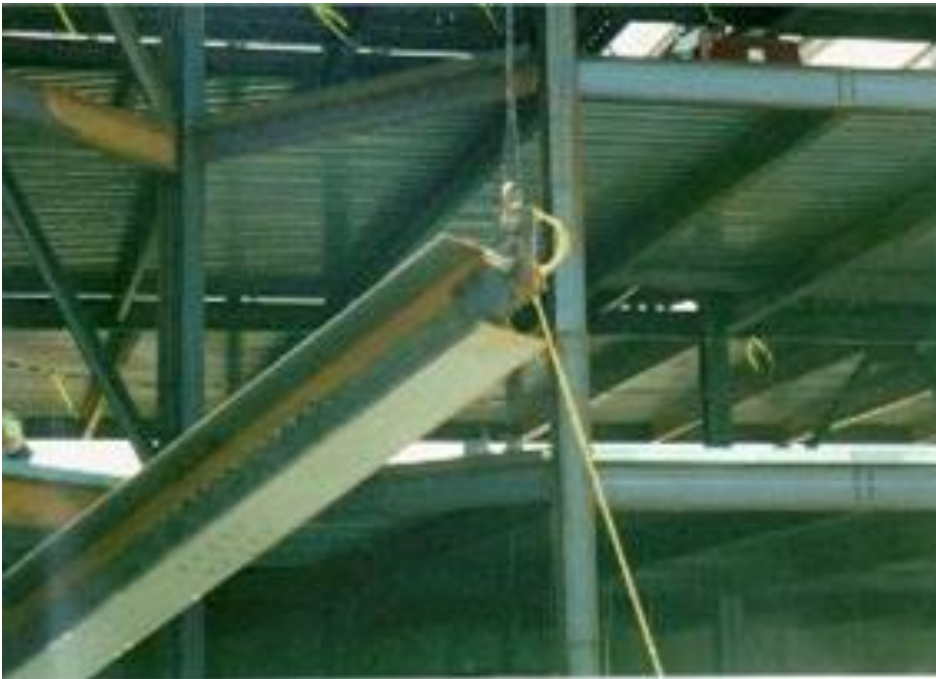
Quick release device for hoisting columns. Pin must be able to lift the column with a safety factor of 6, similar to a sling.

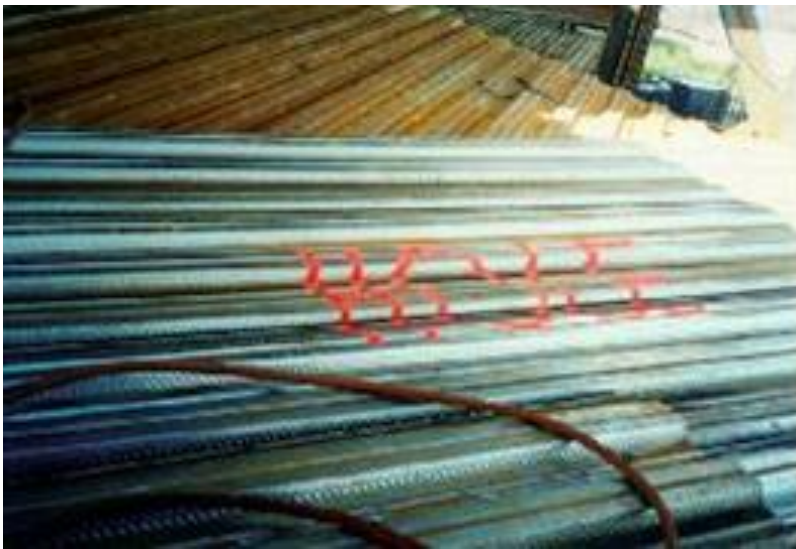
Cover marked and secured.

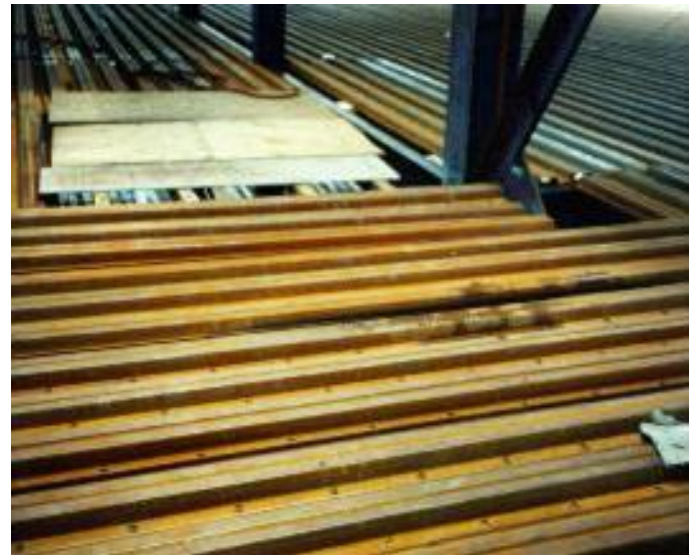
No securement or marking to indicate the opening.

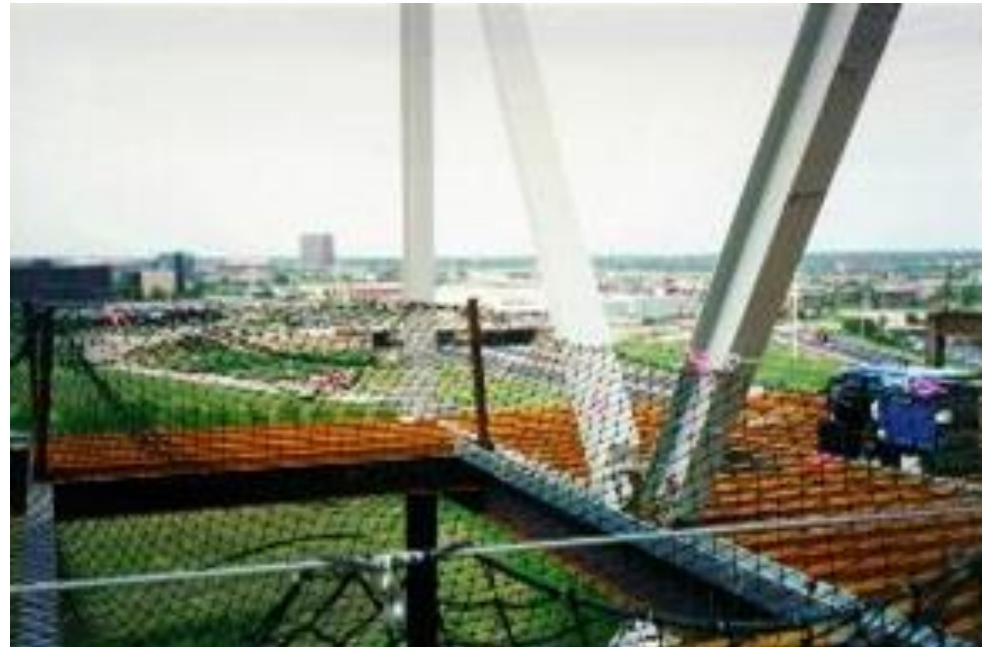
Opening in decking netted to comply with 1926.760(b).

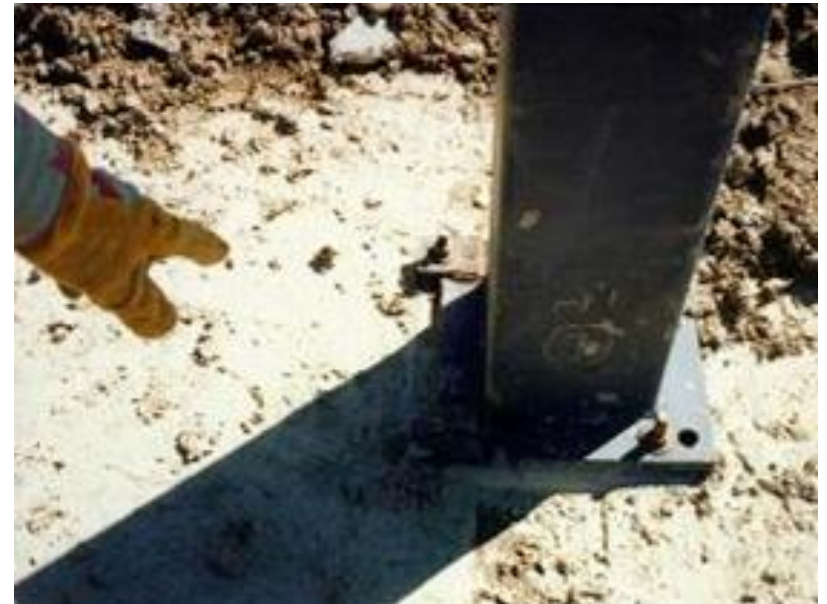
Column would not align with the j-bolts, so the steel erector cut holes and welded tabs to hold column.

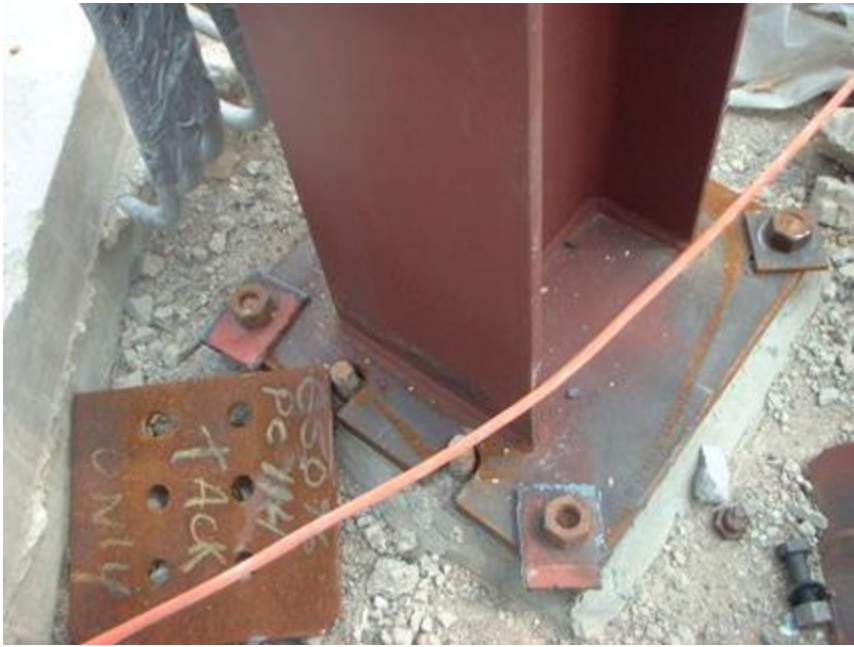
Four bolts used

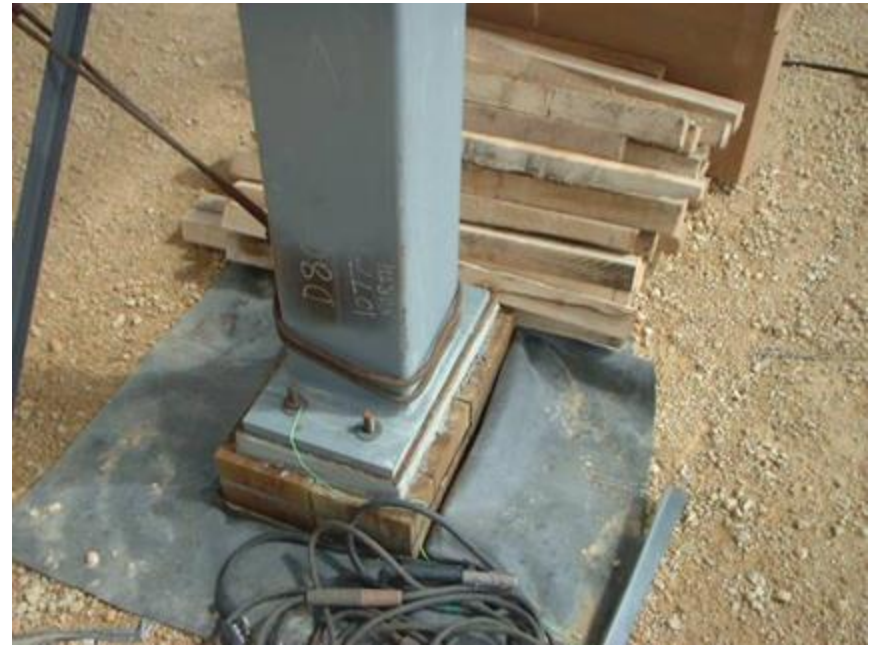
Missing two nuts

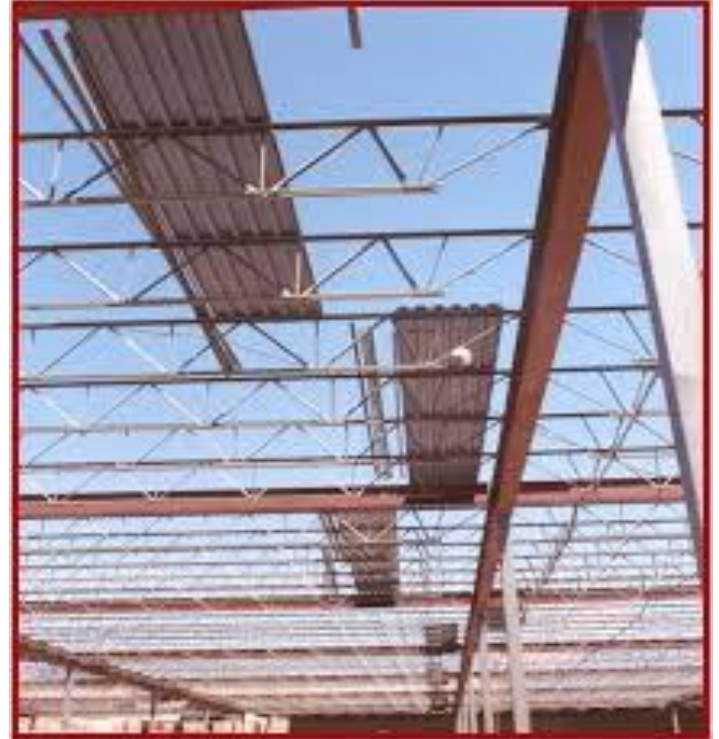
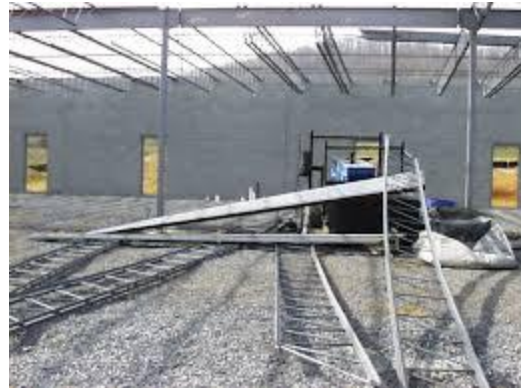
1926.757

- Decking Bundles
- The bundle of decking is placed on a minimum of three steel joists;
- At least one row of bridging is installed and anchored;
- The edge of the construction load shall be placed within 1 foot (.30 m) of the bearing surface of the joist end

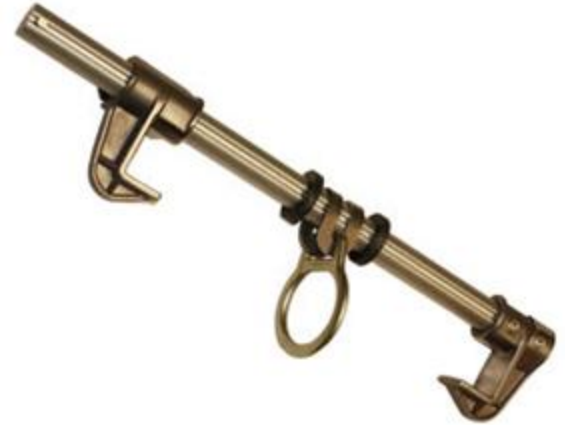
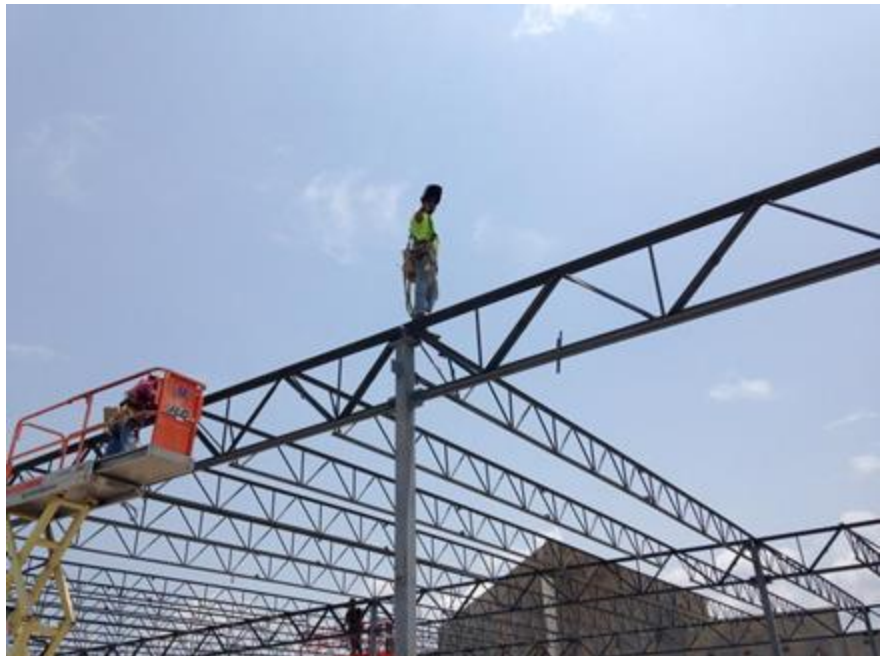
- Using a Beemer style of fall protection.
- Free fall distance is over 6 feet, so manufacturer must approve design and fall arrest system.
- Many connect out of aerial lifts or use horizontal lifelines.

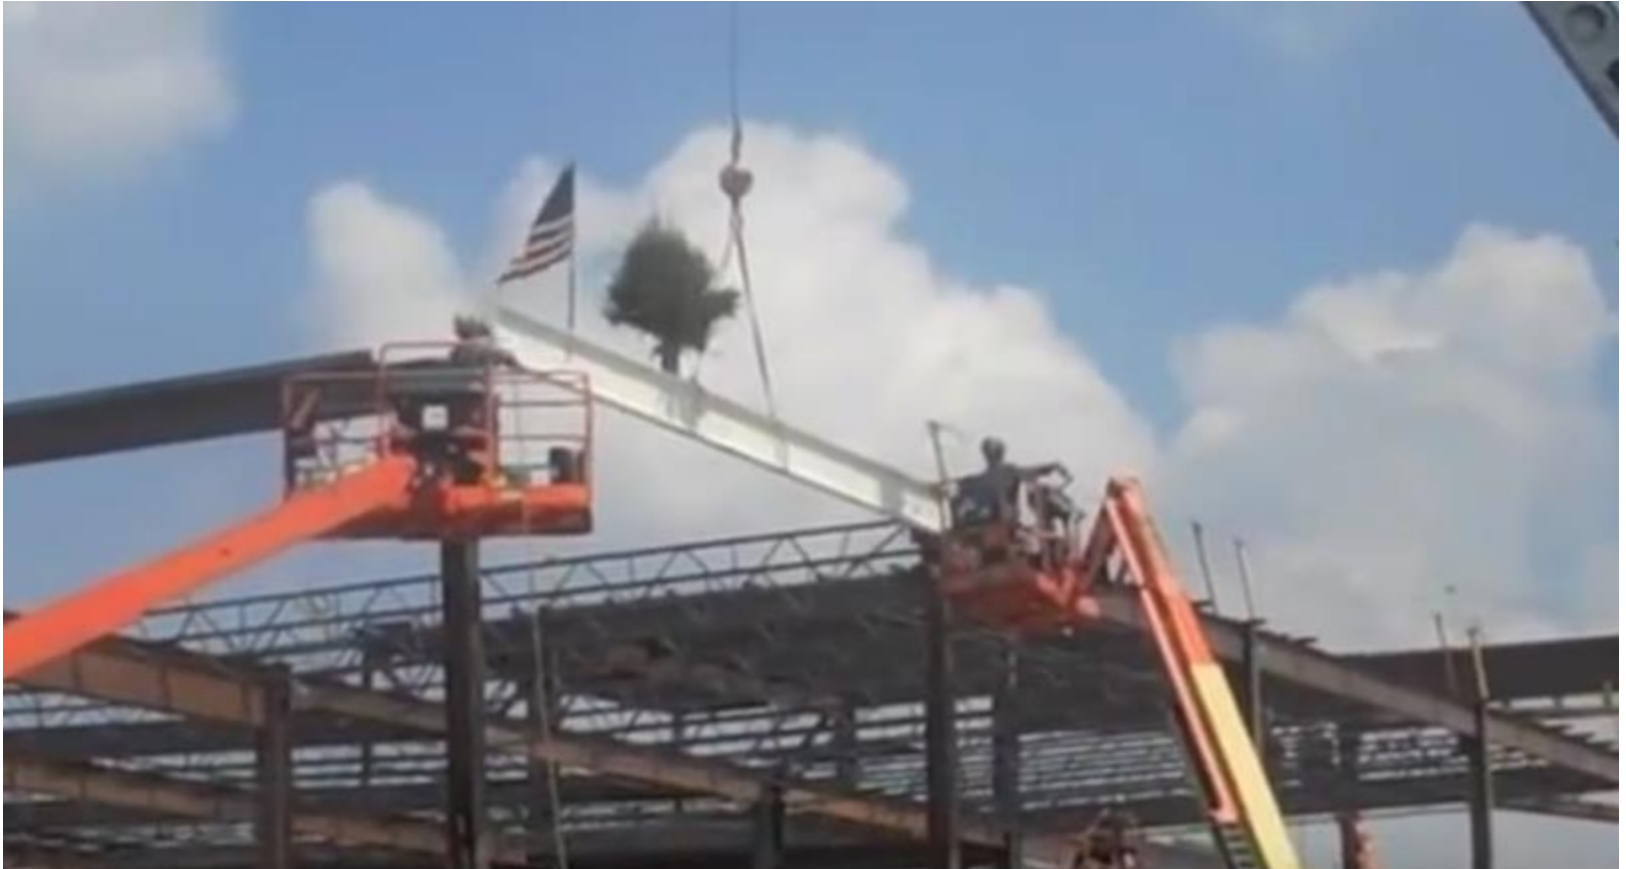
- Malta, IL
- Connecting out of aerial lifts.
- Horizontal lifelines used also.

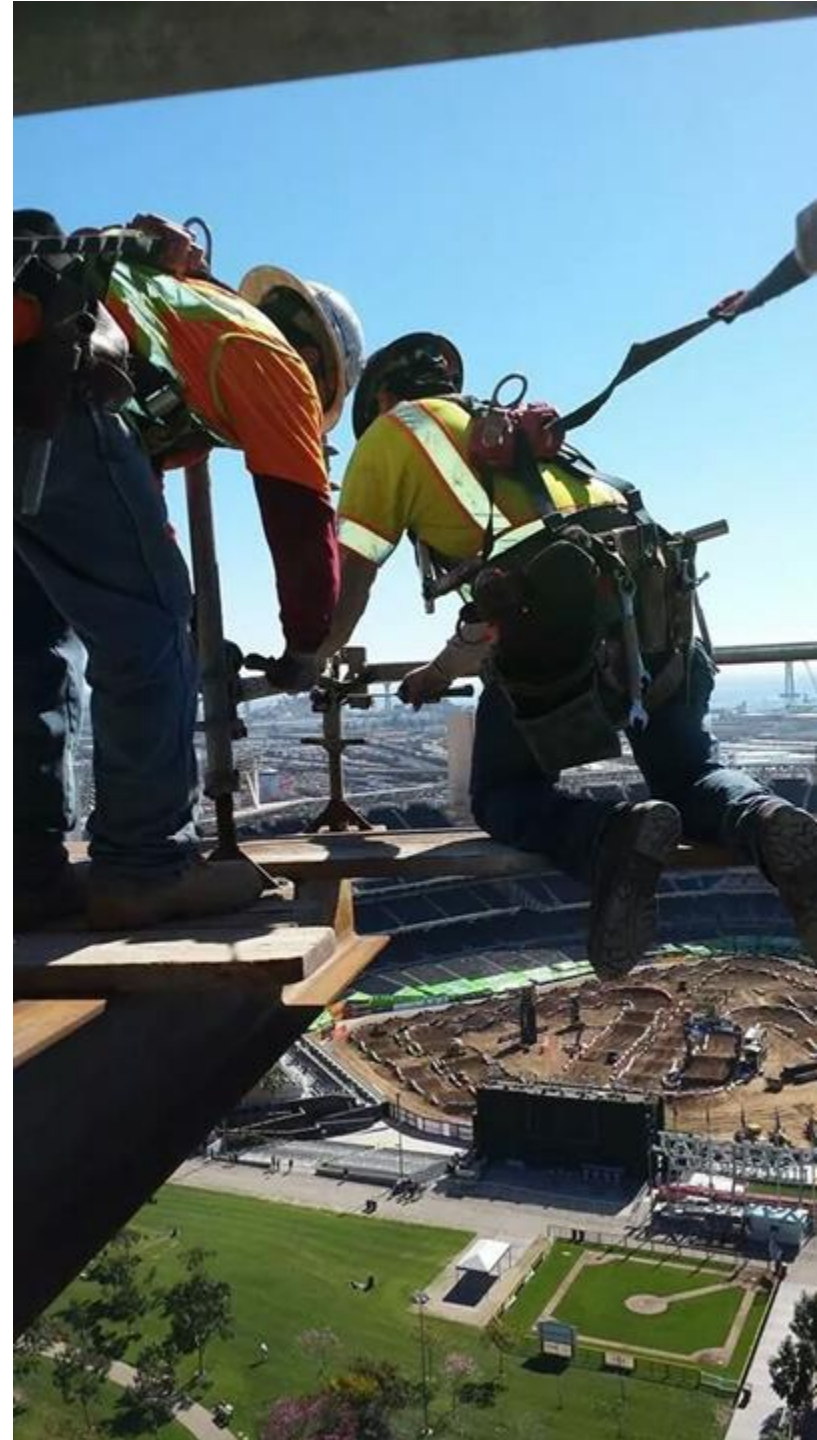
- What hazard is there with using this lanyard?

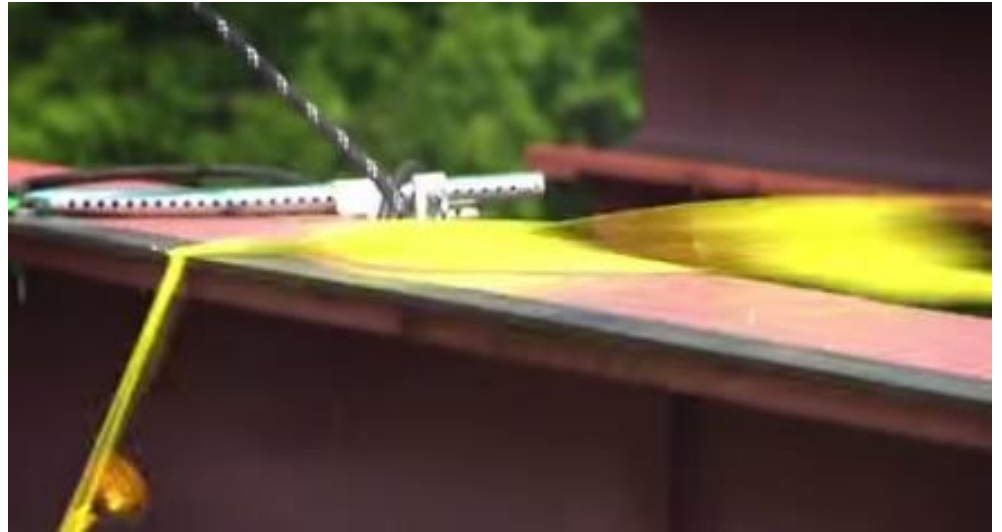
Fabric Lanyards

- Cannot be used on sharp edges.
- ANSI Z359

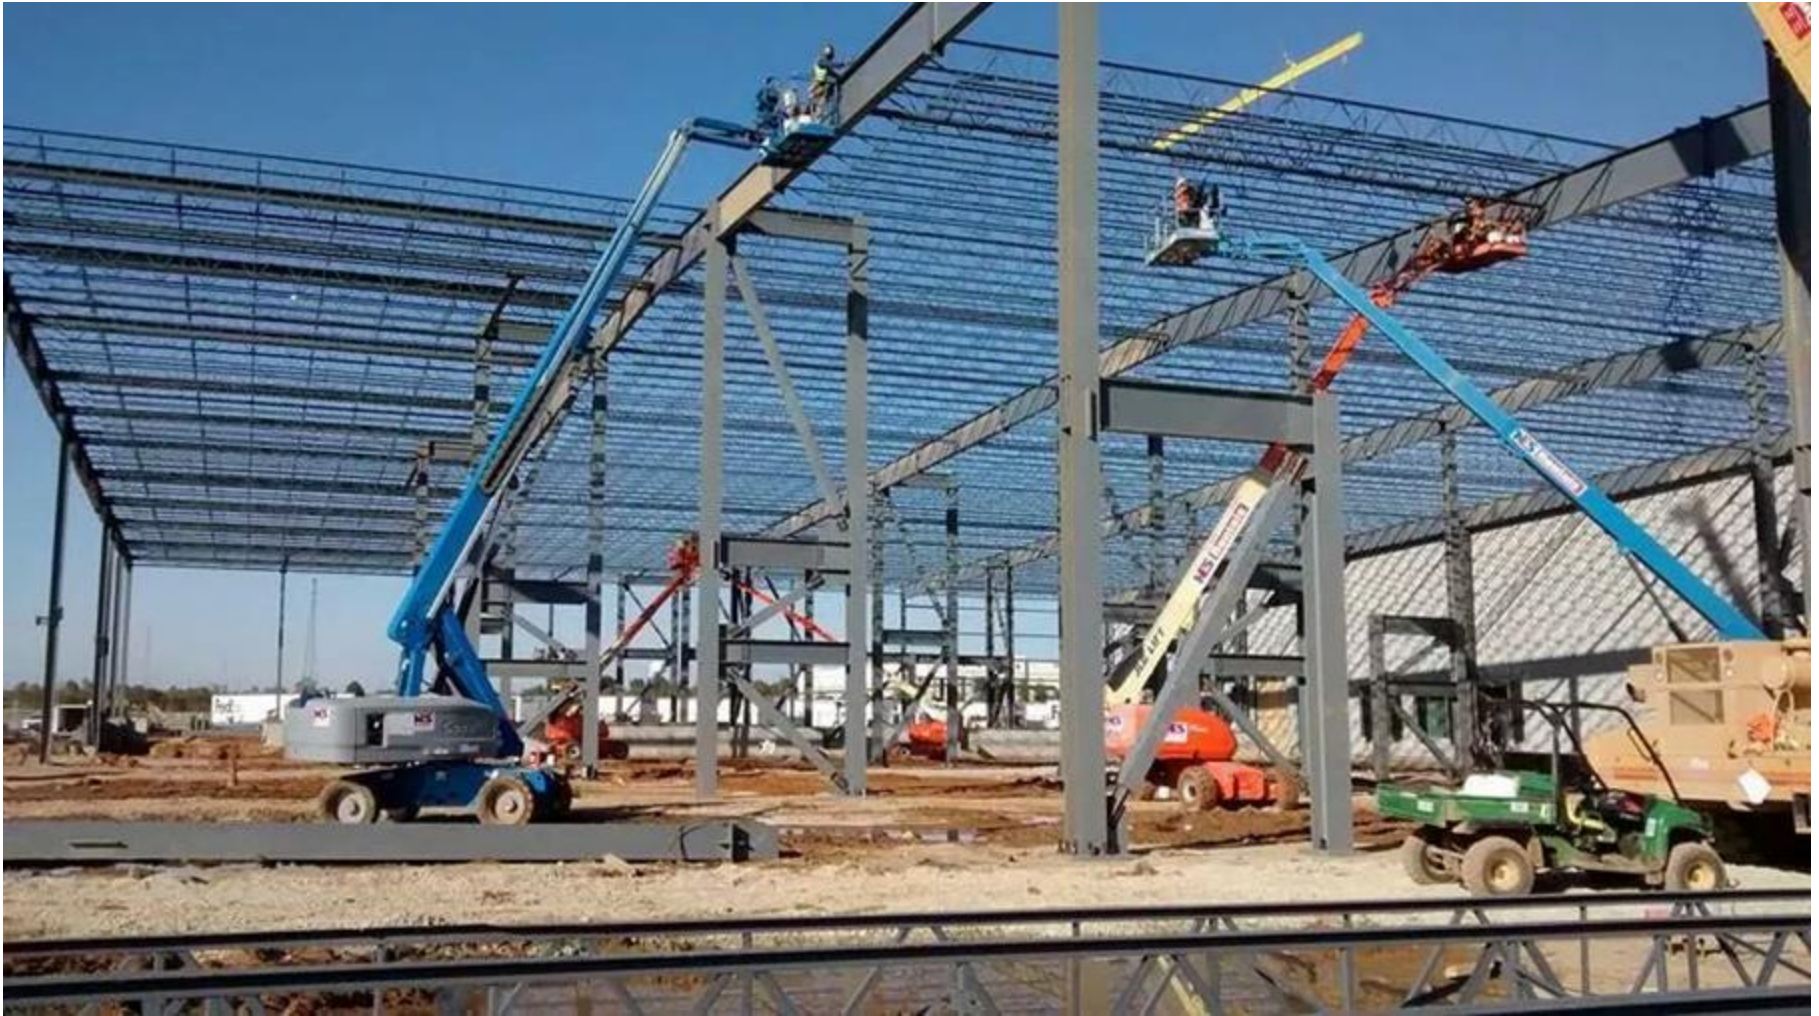
Many jobs can be connected out of aerial lifts.

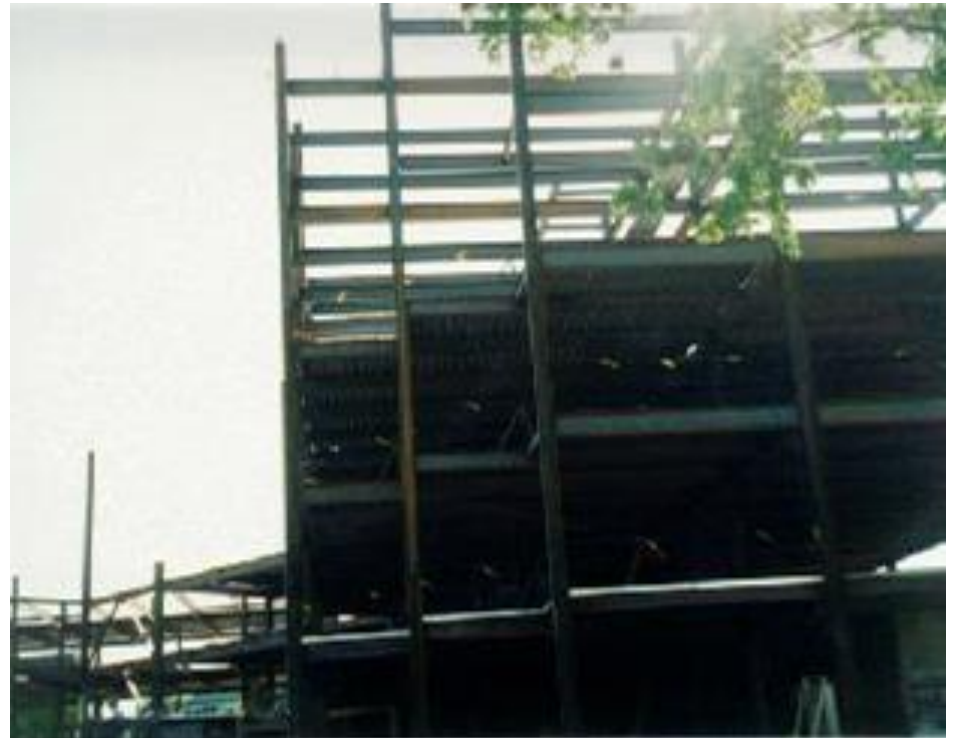
- Perimeter cables required:
 - must be installed “as soon as the metal decking has been installed.”

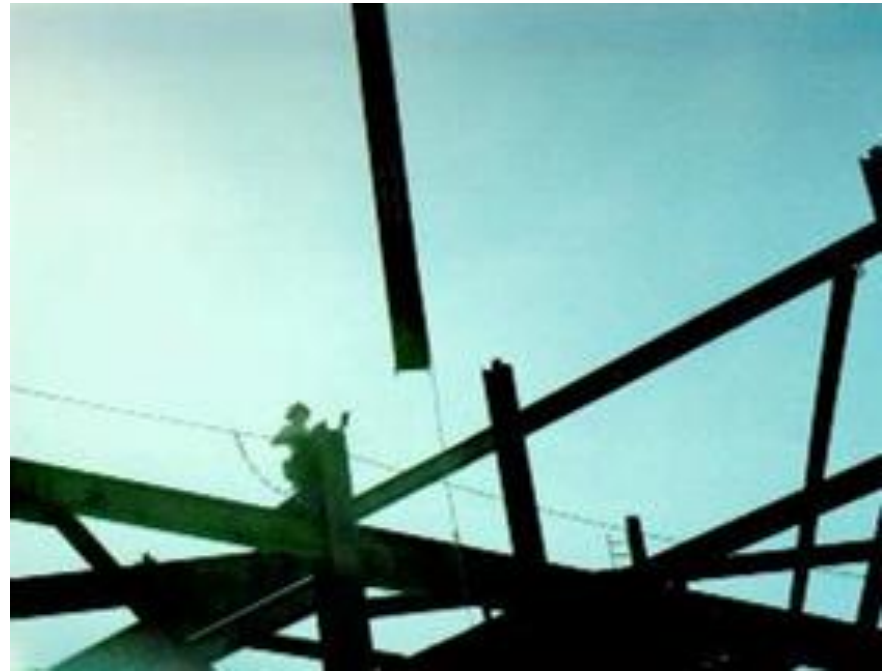
Perimeter cable system

- Controlling contractor must choose to **EITHER**
 - accept responsibility for maintaining fall protection equipment left be erector, **OR**
 - ensure that it is removed (.760(e)).

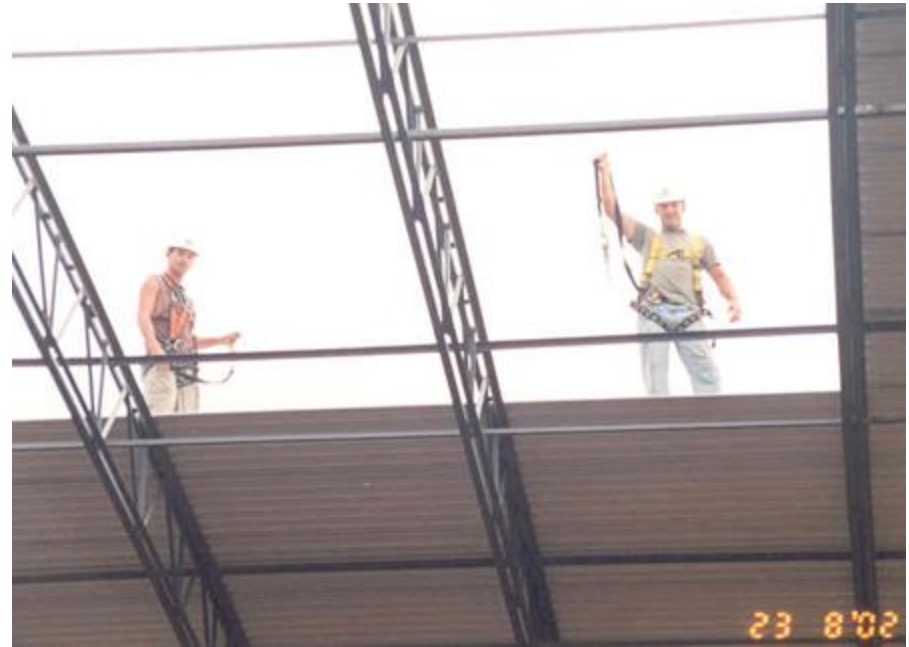
- Deckers must use fall protection above 30 feet.
- Between 15 and 30 feet, a controlled decking zone could be used.
- The Retractable lanyard must be LE (or Leading Edge).

Use of a fall arrest cable parallel with leading edge set back behind the decker is the most common method in IL.

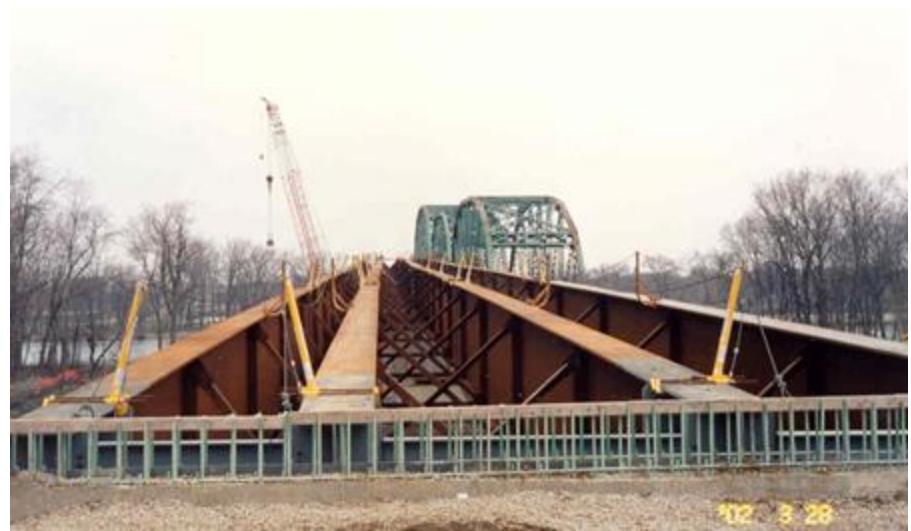
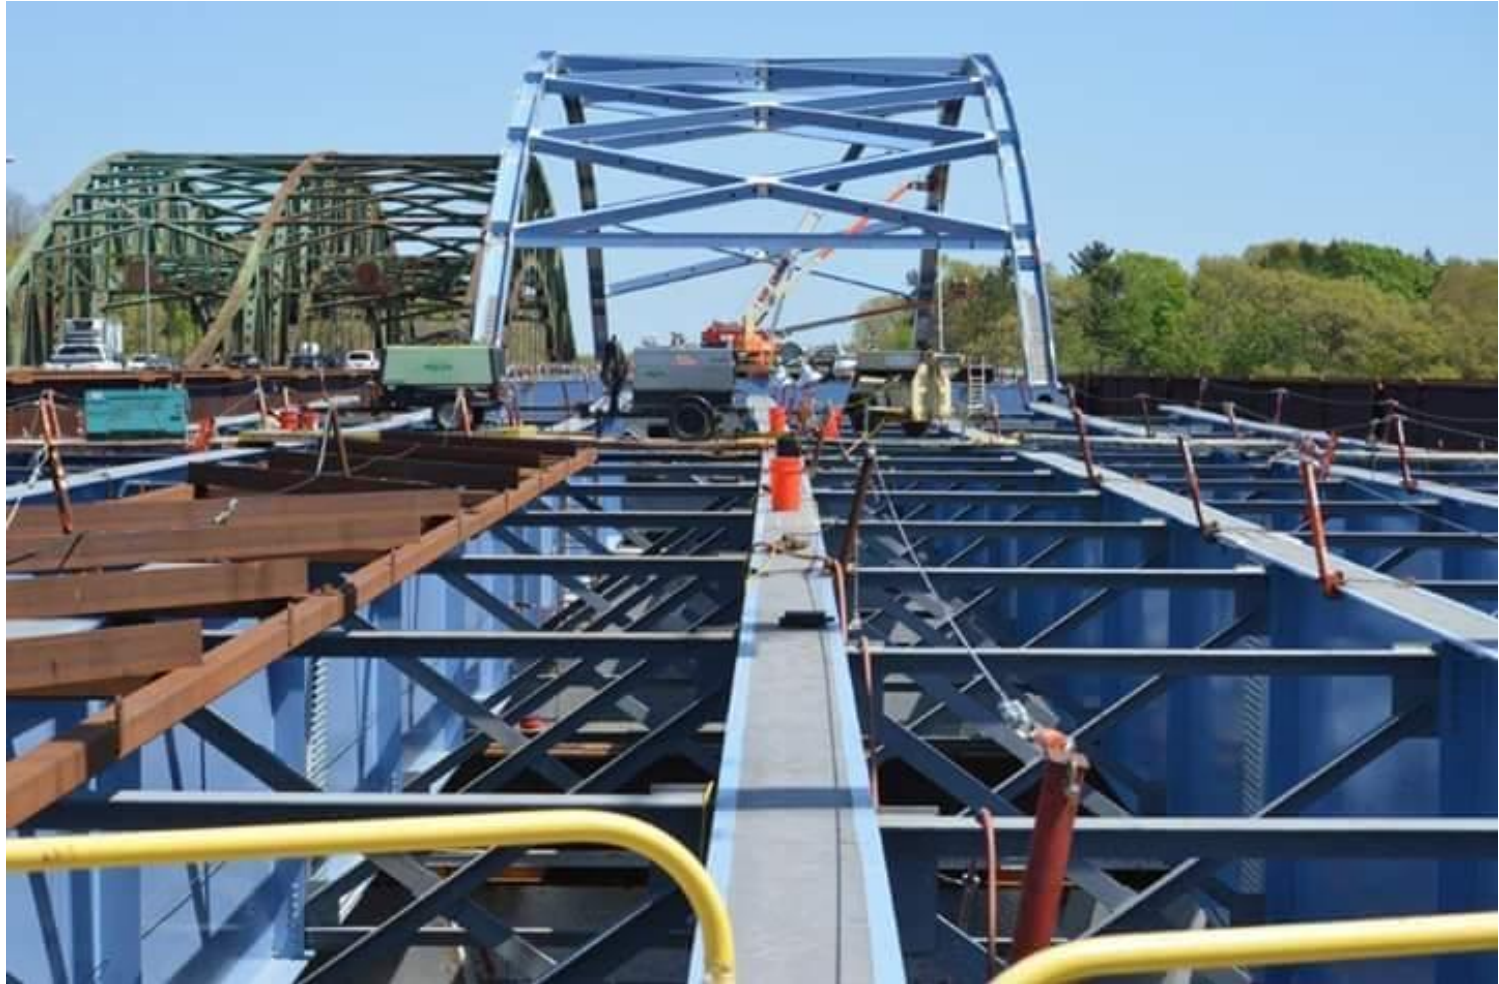
Amesbury, MA bridge

- Fall Protection is most commonly done by fall arrest systems.
- The vertical component is offset to allow walkthrough.
- Workers use a double lanyard system.
