Casino Collapse

OSHA Steel Erection Standard

Draft 7 15 2019

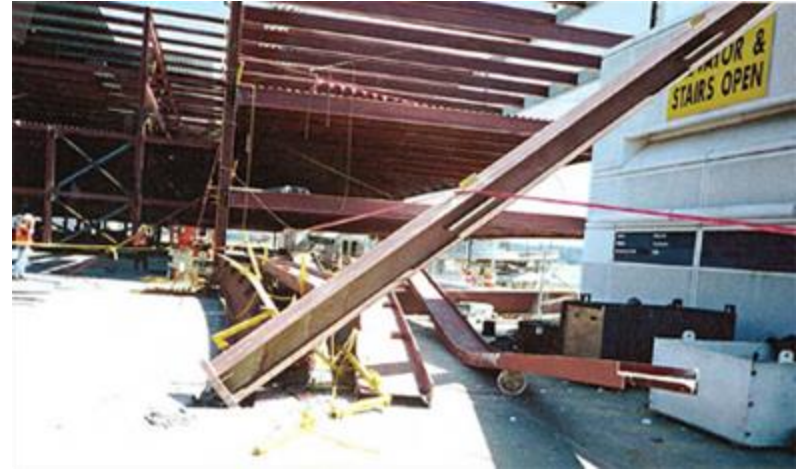
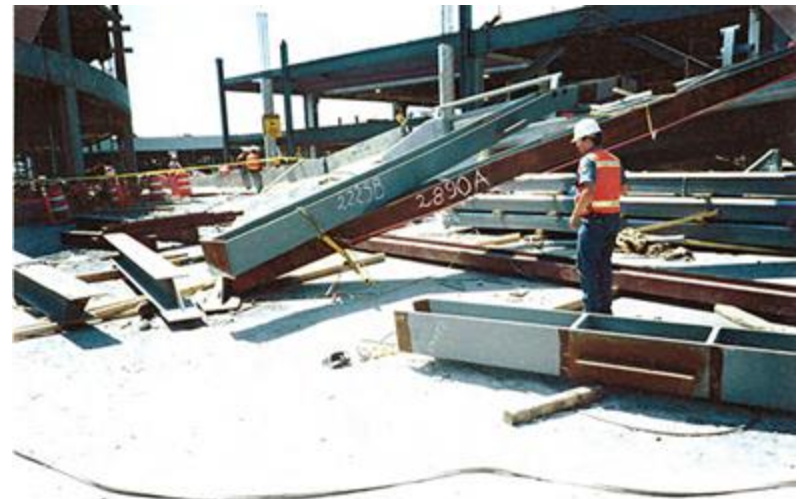
- Three union Iron Workers were killed July 31 when a 150-foot section of a seven-story parking garage under construction at Portland International Airport collapsed.
- The steel erector failed to provide temporary bracing and guys to the erected steel columns to secure them against any lateral load due to wind and/or any incidental construction load.

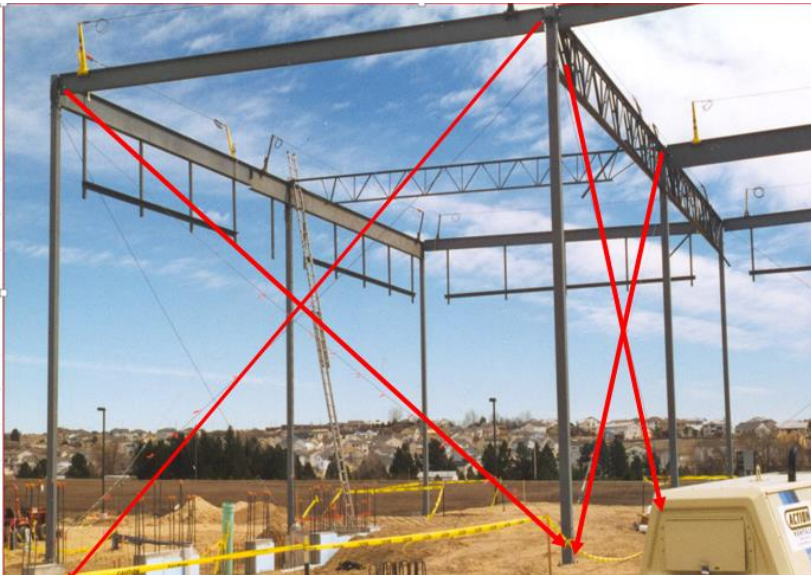
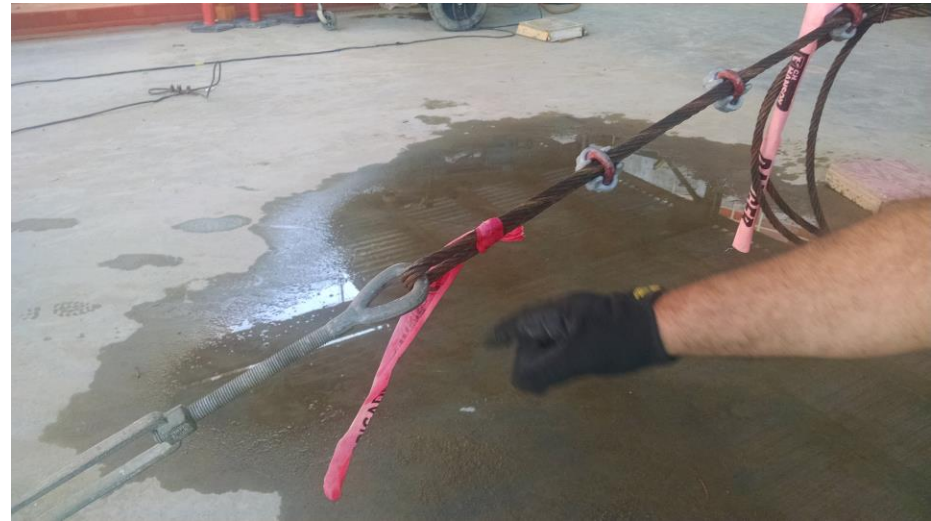
- Columns evaluated whether guying and bracing needed

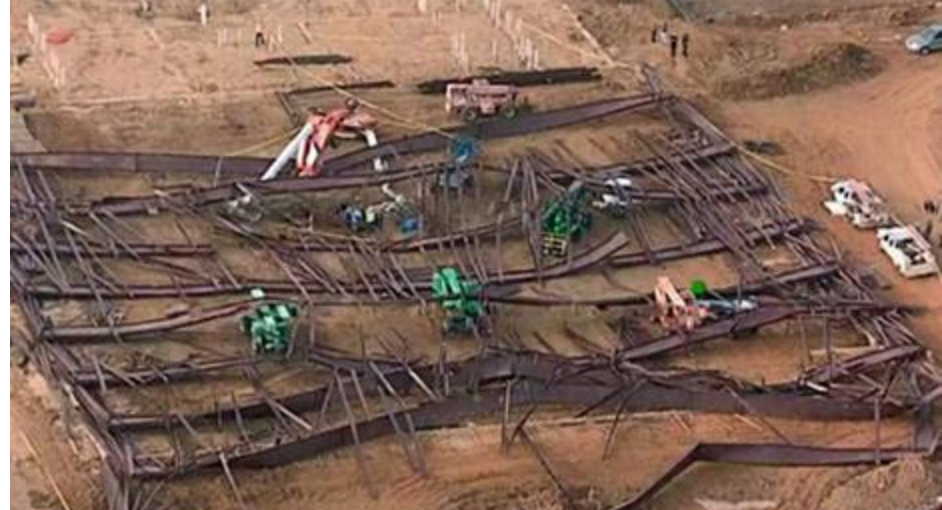
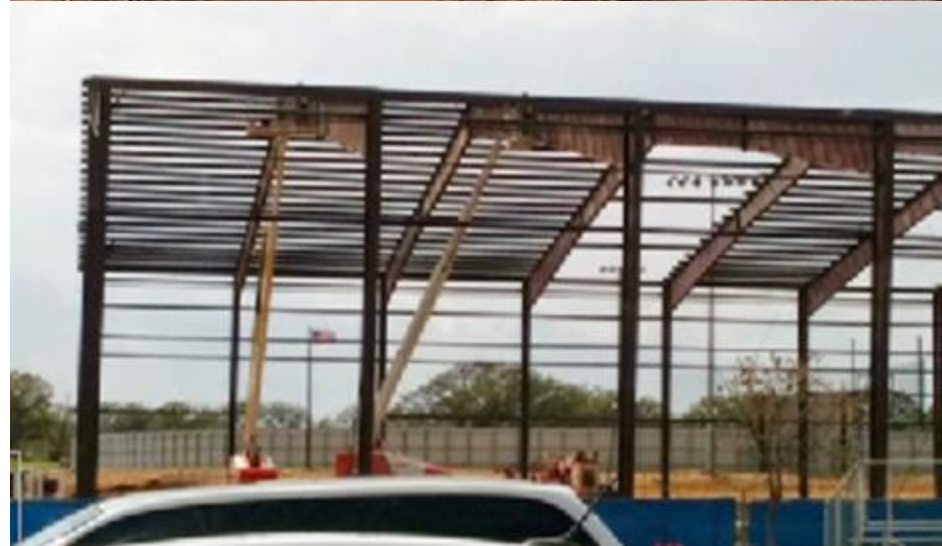
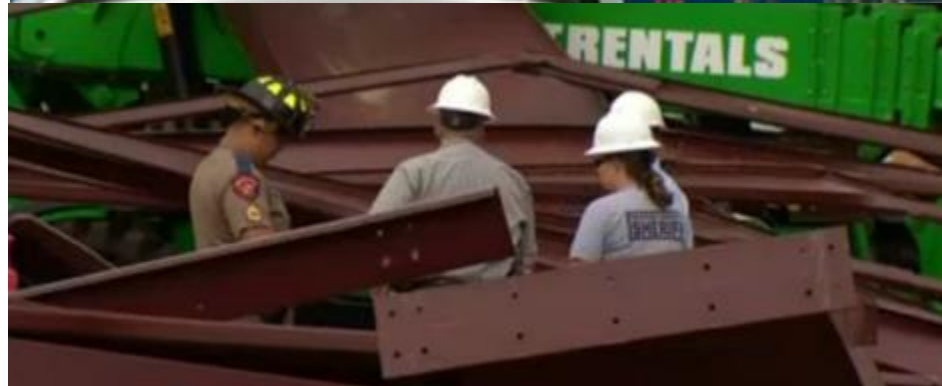
- Argyle, TX
- One killed, several hurt.
- Gusts 30 mph.
- Wright said the Northstar Builders Group was responsible for the construction, which is part of a \$45-million bond package that includes new tennis courts and new turf for the athletic fields.

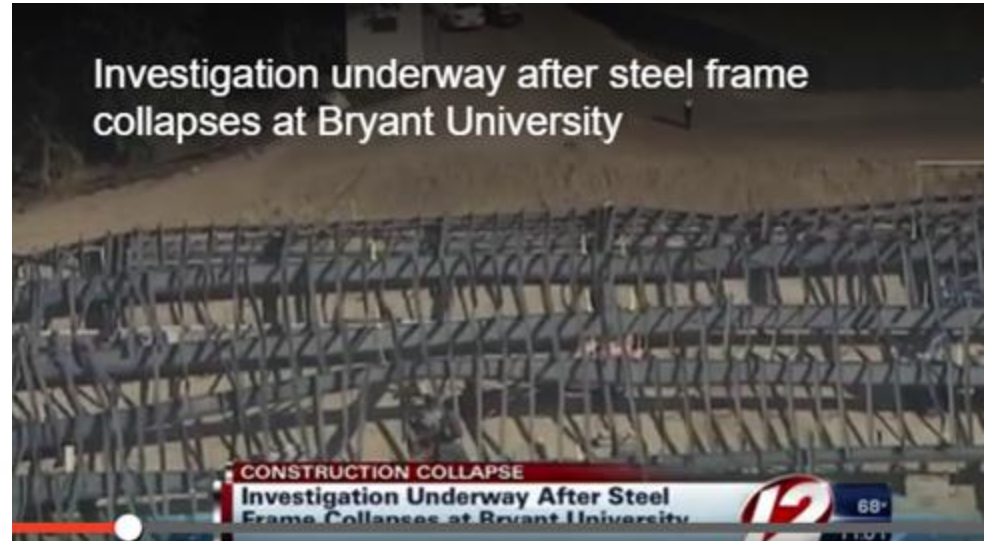
29 CFR 1926.754(a): Structural stability was not maintained at all times during the erection process:

(a) Worksite - Indoor Practice Facility: On or about 9/1/2015, the employer did not install adequate bracing during the steel frame erection process to ensure the structural stability of the framework.

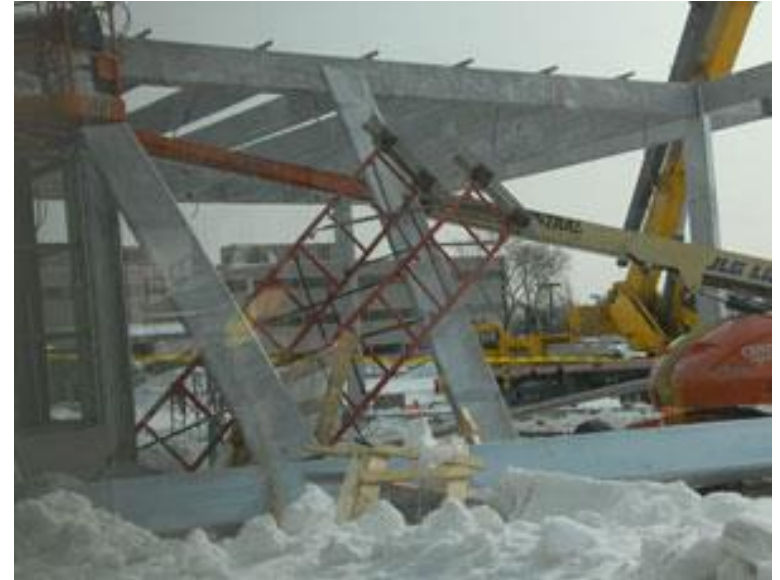
- February 2011
- Employee # 1 was killed when the entire western cantilevered bay of the steel canopy structure collapsed and one of its steel members struck him.
- The steel beam was a component of a steel canopy structure that consisted of three bays: a western cantilevered bay, a center bay and an eastern cantilevered bay.
- The shoring towers were inappropriately placed and the stability of the structure was compromised.
